MINISTRY OF WAR TRANSPORT,
Berkeley Square House,
London, W.1.

15th March, 1944.

We have the honour to report for the information of the Minister of War Transport, in accordance with the Order dated 17th January 1944, the result of our Inquiry into the collision which occurred at about 7.20 p.m. on Sunday, 16th January 1944, at Ilford Station Up Through platform, about 7 miles from Liverpool Street, on the London and North Eastern Railway.

L. N. E. R.
(SOUTHERN AREA)
COLLISION AT ILFORD

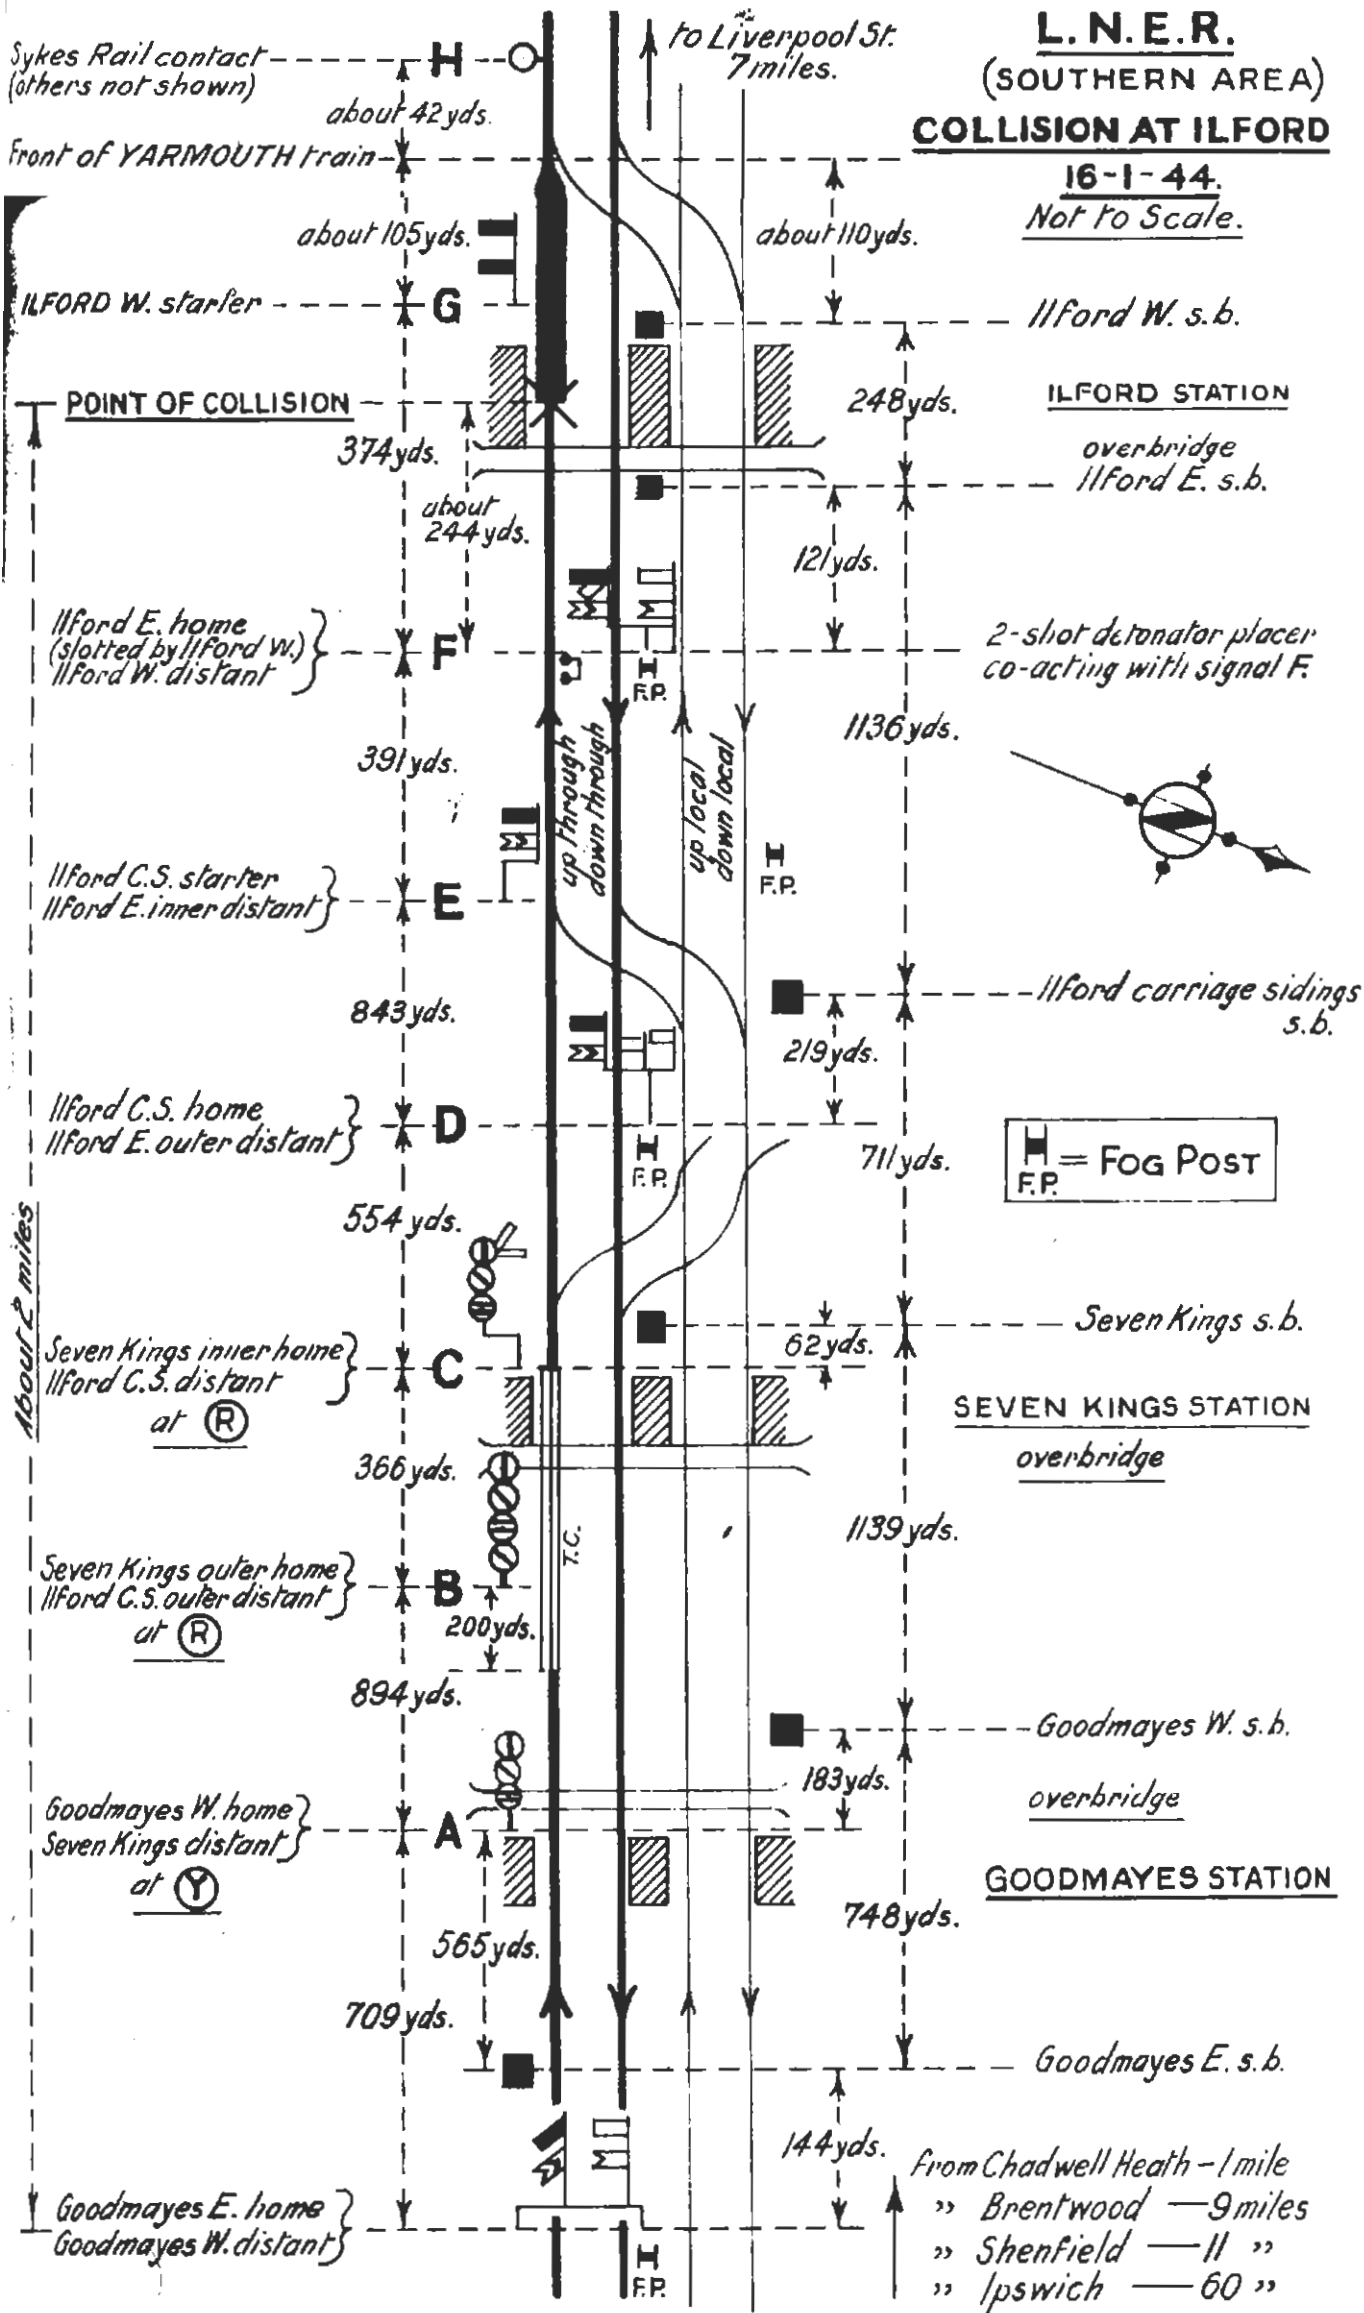
3. With reference to the diagram, the Up Through semaphore signals D, E, and F are fairly high, viz. 25 ft. to 33 ft. above rail level, and it is doubtful whether their oil lights would have been visible from the footplate under the prevailing conditions; it will be noted that their fog posts, which were not manned, are all situated to the right of the Up Through line. None of the signal boxes concerned is equipped with emergency detonator placers.

The multi-lens colour-light signals A, B, and C, which were the key to the situation, are sited to the left of and close to the Up Through line, and are of standard height, viz. practically level with the driver's eye; their lights have double filament bulbs, the secondary filament being brought into use automatically if the main filament fails. They were installed in their final positions under the electrification and re-signalling scheme when the track layout at Seven Kings was remodelled recently in the course of ordinary renewals, and Seven Kings East box was abolished; they were brought into use on 24th October and 19th December, 1943 (see Appendix I for extracts from the relevant notices). Signal C replaced a semaphore signal fitted with a co-acting detonator placer, which was removed.

Thus, there can be no reasonable doubt that signals A, B, and C were displayed at YELLOW, RED, and RED respectively for the Norwich train, the enginemen of which were Driver T.E. Latter, and Fireman F.W. Trout.

As already stated, there can be no reasonable doubt that signals A, B, and C were displayed at YELLOW, RED and RED respectively for the Norwich train, while those at D, E, and F were also at Danger. No criticism arises as regards the operation of the signalmen, and those at Seven Kings, Ilford Carriage Sidings, and Ilford East appear to have acted promptly; but they could do little to prevent the collision, in view of the short intervening distances and the speed of the train.
